Manhole Inspection Summary

Manhole # S25E__045MH

Insp Date: **8/7/07 8:41 AM**

Location Address: **1215 SARATOGA ST**

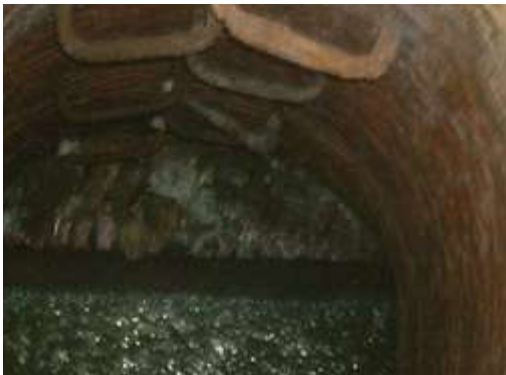
Defect 3

☒ **Evidence Of Surcharge** Depth: **2** (ft.) ☐ Active Surcharge Present

SURCHARGE EVIDENCE ON STEPS

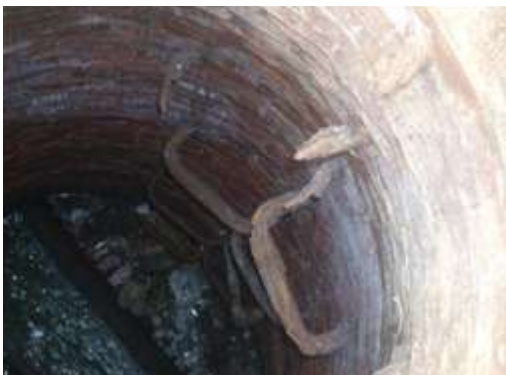
Defect 1

Count: **6** Missing: **3** ☒ **Corroded**

MISSING AND CORRODED STEPS

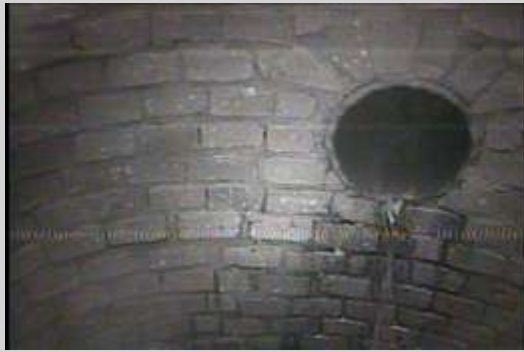
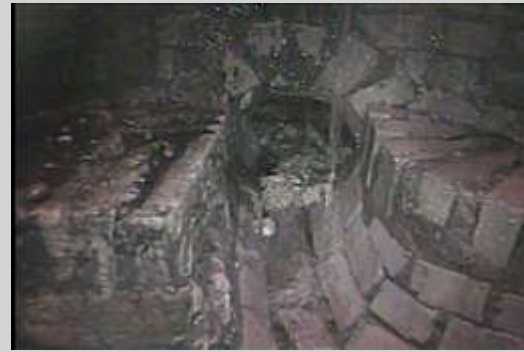
9 O'Clock Inflow

Deposits: ☐ None ☐ Mud ☒ **Sludge** ☐ Debris ☐ Grease

Silt Depth: **5** (in.) Deposits Extent: **Heavy**

Drop Condition: **Partly Clogged**
